BUILDING MATERIALS AND SUSTAINABILITY OF THE ENVIRONMENT

(YAPI MALZEMELERİ VE ÇEVRENİN SÜRDÜRÜLEBİLİRLİĞİ)

EDITOR
Assoc. Prof. Dr. Mehmet SÖYLEMEZ

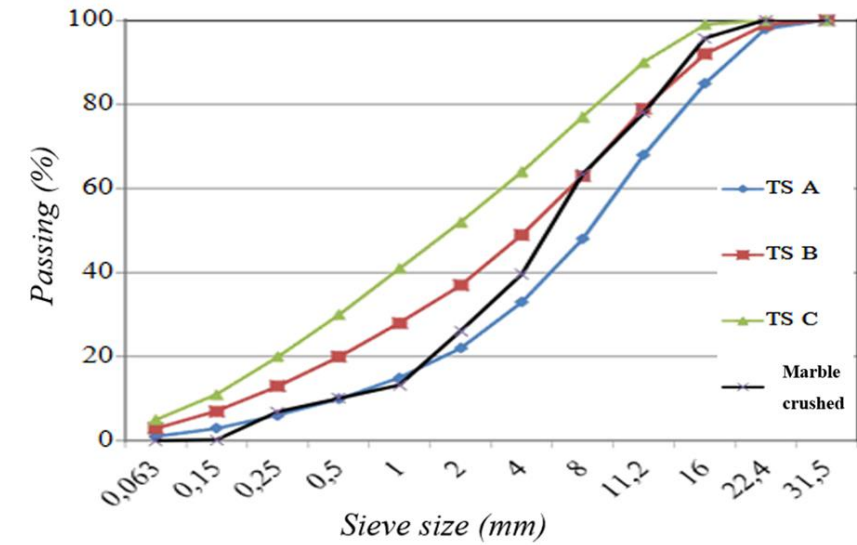
Figure 1. The aggregate used's granulometry curve

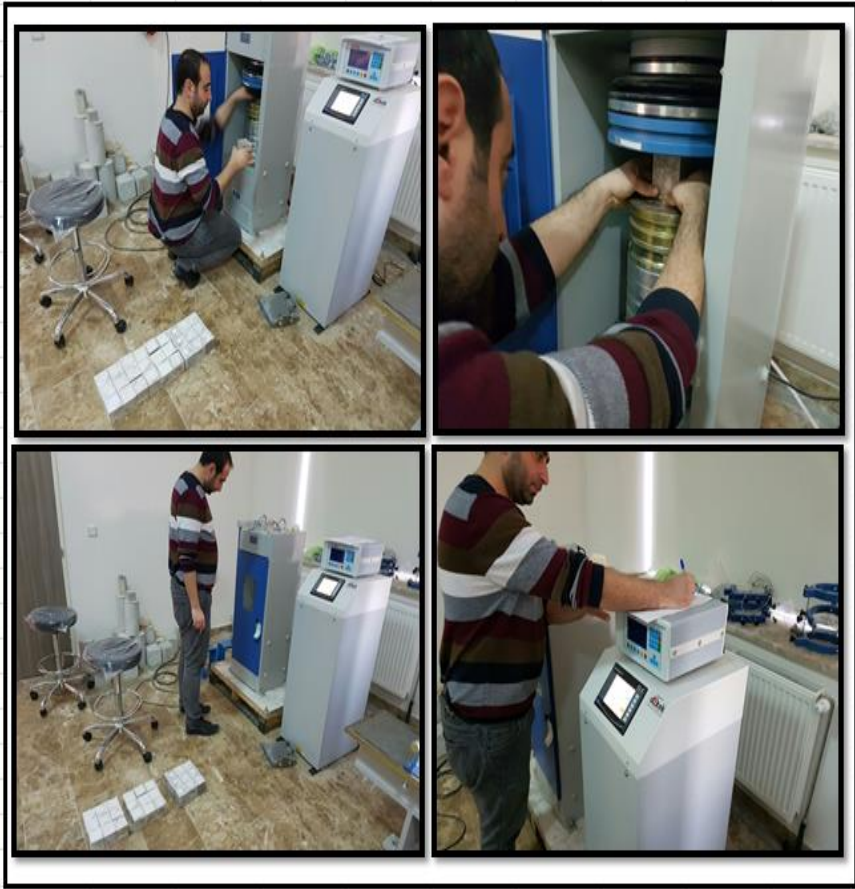
According to TS EN 12390, concrete samples were forced into a 200-ton pressure press at a continuous loading rate of 6 kgf/cm².sec. The greatest stress value recorded by the computer was then read. The compressive strength values are determined as f_c (MPa) from the relation $f_c = P/A$, where the reading P (N) represents the area A (mm²) to which the pressure force is applied (Figure 3). The determined concrete strength values are shown in Figure 4.

Figure 3. Concrete that has been hardened and measured for compressive strength

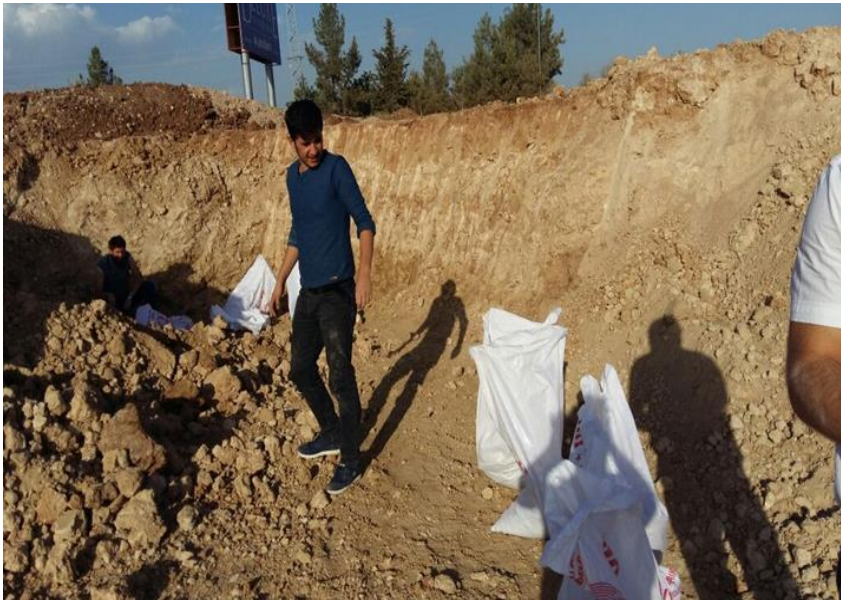
Figure 1. A View From The Sampling Locations

The potential for making bricks from waste clay soils excavated in construction foundations in the Adyaman province was investigated for the first time in this study, without causing harm to agricultural lands (Fig 1). A few engineering and firing properties of clayey soils produced by foundation excavations were also studied.

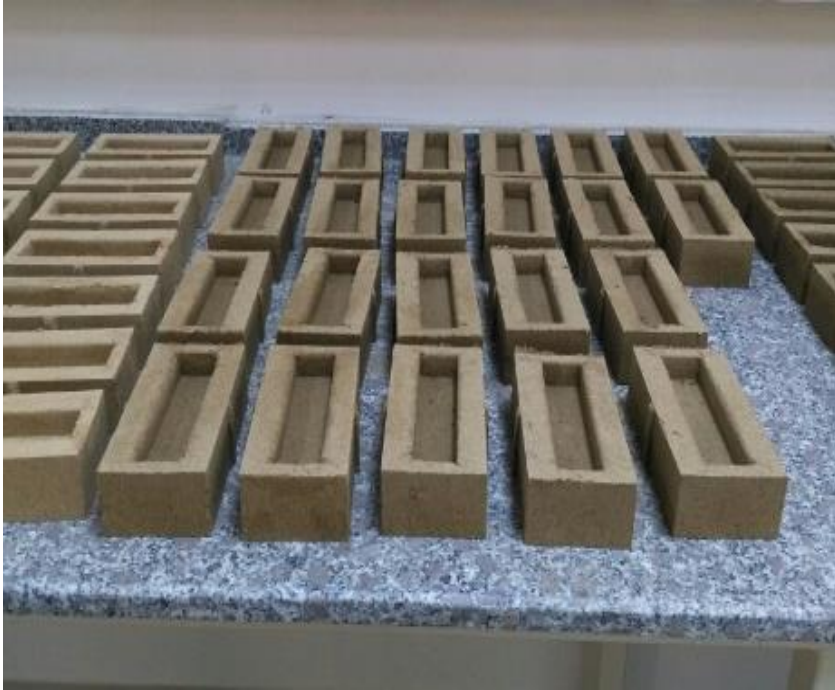
The clay-rich materials were crushed and combined with 17 percent water content after being oven-dried at 105 °C to improve particle binding and make bricks of the required size. Bricks measuring 15 cm x 7 cm x 4 cm were made to test the firing characteristics of the samples (Fig. 2).

Figure 2. Bricks produced in the dimensions of 15 cm x 7 cm x 4 cm

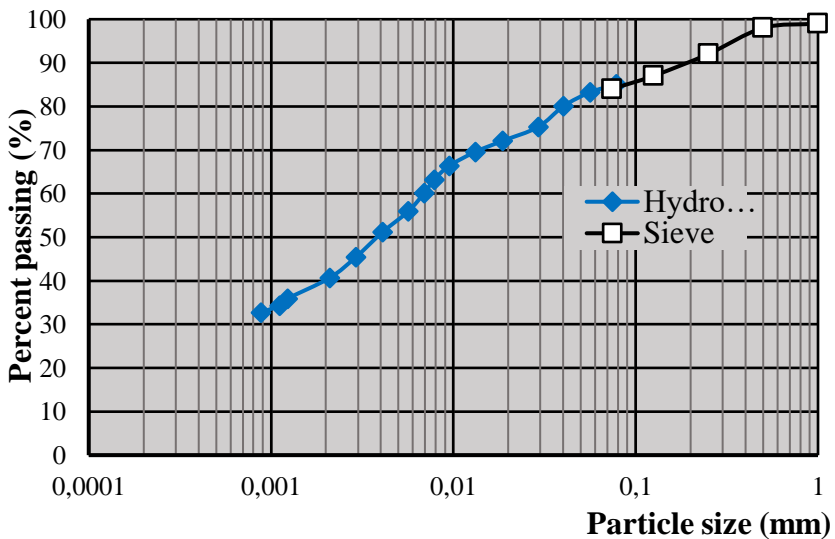
In the technology of ceramic and brick manufacturing, clayey soil particle size distributions (PSD) are a definitely necessary indicator. (Andrade et al., 2011; Öser, 2020; Rowe et al., 1983; Sridharan et al., 1998). The samples under study have a wide range of particle sizes. The soil used in the experiments for making bricks contains 16.77 % sand, 43.15 % silt, and 40.08 % clay (Fig.3).

Figure 3. The Particle Size Distribution Of The Clayey Soils Used In The Experiments

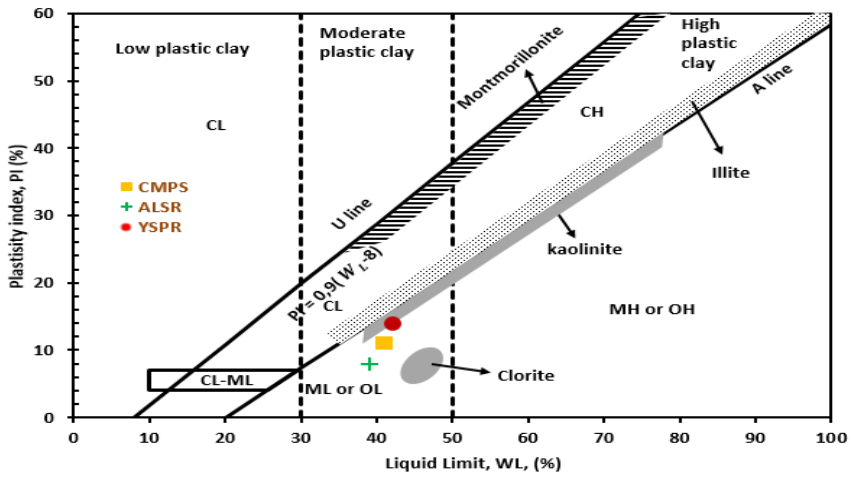
Figure 4. Plasticity Properties Of CMPS, ALSR, And YSPR Samples (Casagrande, 1948)

The relationship between the porosity, plasticity, and permeability characteristics of the clayey soil samples used in the studies and the PSD ratios is shown by the plasticity table and the triple diagram. The PSD of these clay-rich materials is also similar to the PSD of the clay-rich Manisa (Turgutlu) and Denizli clays, which are used to make the majority of Turkey's bricks and tiles. Clay soils suitable for brick production are divided into three types: silty clay or clayey silt, loam, and sandy clays and sandy silts. All samples were classified as clayey silt with little plasticity. All samples collected from various areas of the same geological soil layer had similar ratios of clay, silt, and sand as well as similar plasticity characteristics. (Table 1, Fig. 4 and Fig. 5).

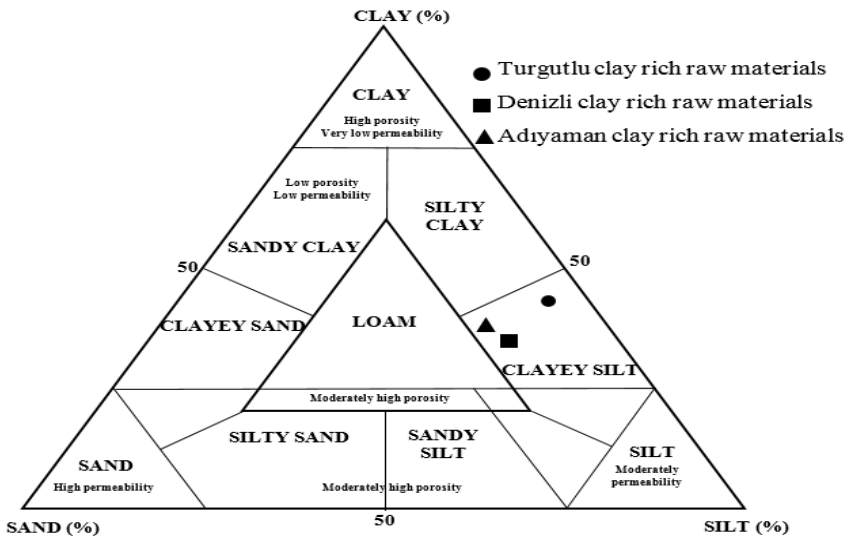
Figure 5. The Relationship Between Porosity And Permeability Of Clay, Silt And Sandy Soils

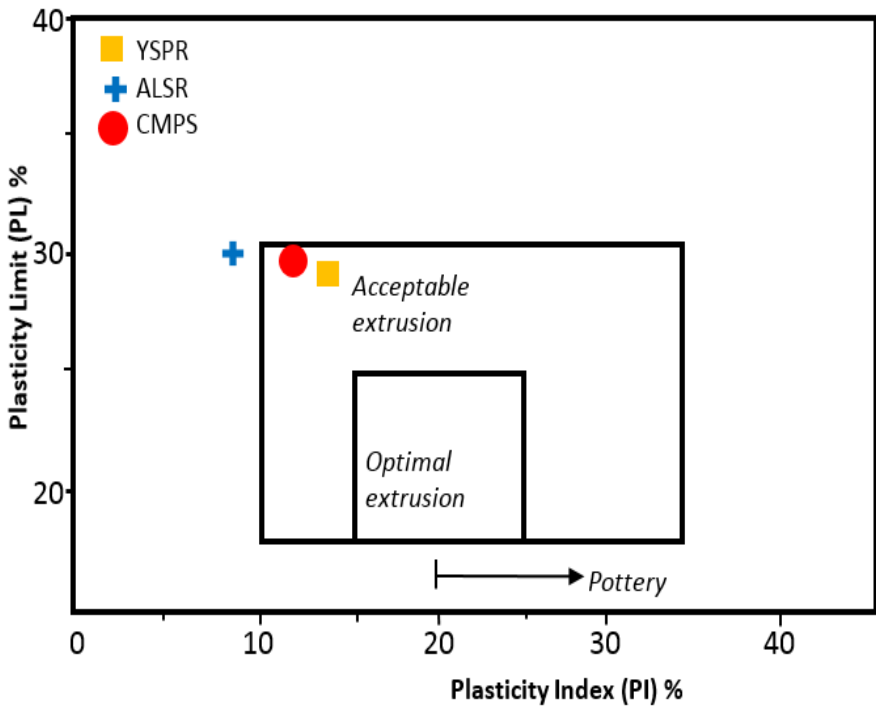
Particle size distribution information often explains differences in sample plasticity. (De Wang et al., 2008; Ngun et al., 2011). The plasticity and workability of the raw materials used to produce ceramics and bricks are influenced by the presence of clay. (Andrade et al., 2011; Baran et al., 2001; Diko et al., 2011). (Fig. 6).

Figure 6. Positions Of The Samples Of Clayey Soil Used In The Tests On The Workability Card

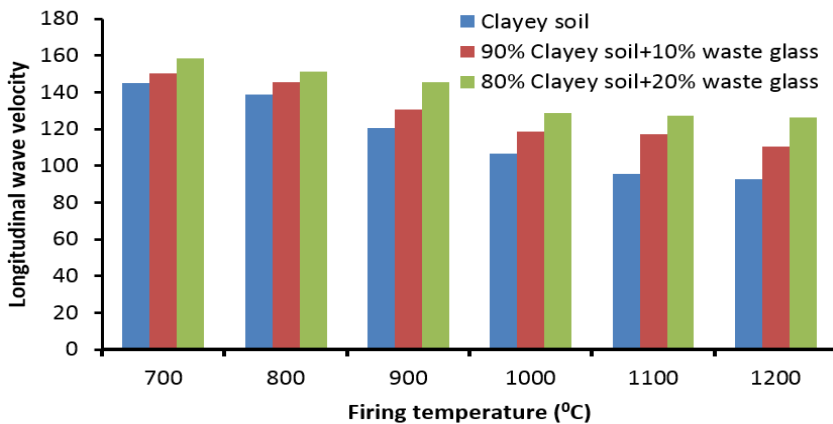
The longitudinal wave velocities, water absorption rates, firing losses, and unconfined compressive strengths (UCS) of clayey soils are all significantly influenced by the firing temperature (700 °C–1200 °C). As the temperature of the firing increased, the longitudinal wave velocities of the brick samples fell. The samples' greater porosity may be the cause of this intriguing finding, which goes against expectations (Fig.9).

Figure 9. Variation Of Longitudinal Wave Velocity With Temperature

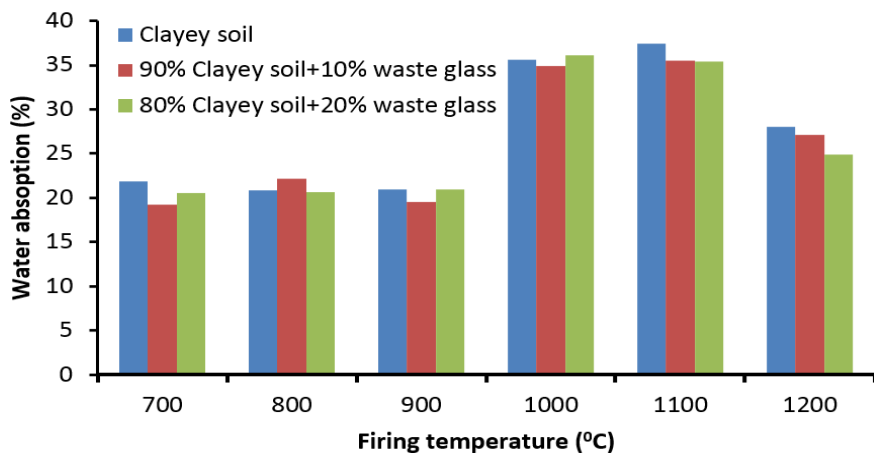
The water absorption amount of the brick samples is at the highest level between 1000 °C -1100 °C. This can be explained by the porosity increasing as a result of some minerals evaporating. Between 700 °C and 900 °C, the water absorption values for all samples were around 21%. The essential minimum temperature for mineral transformation has been attained, as evidenced by the abrupt change in water absorption rates at 900 °C. (Fig.10).

Fig. 10. Variation Of Water Absorption With Temperature

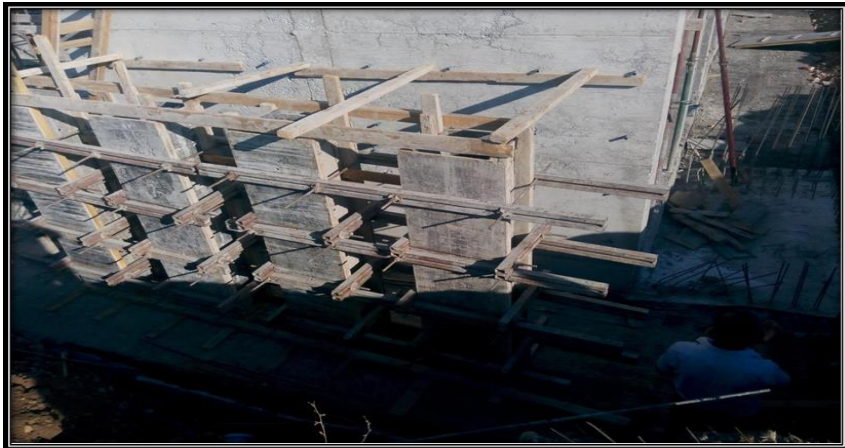
In the study, 4 pieces of 40x40x250 cm (plywood) reinforced concrete form were installed (Figure 1). The form surface was formed in a way that would not leak the concrete water and the surfaces to come to the concrete were lubricated. The concrete form used is reinforced to withstand 8000 12000 revolutions per minute.

Figure 1. Concrete Forms Established For The Study

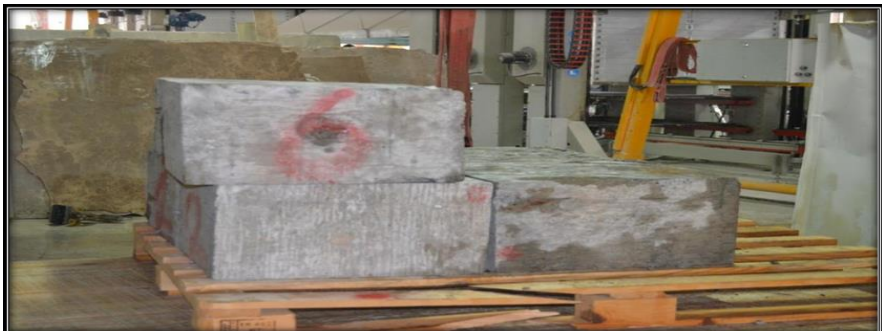
Column concrete was kept in the construction site for 5 months and at the end of this period, the columns were taken to Adıyaman marble factory for cutting. The columns were cut from the lower, middle and upper regions with the este machine. $4 \times 3 = 12$ rectangular prism concrete samples measuring 40x40x25 cm were removed from the columns (Figure 3).

Figure 3. Concrete Samples Cut To 40x40x25 cm Dimensions

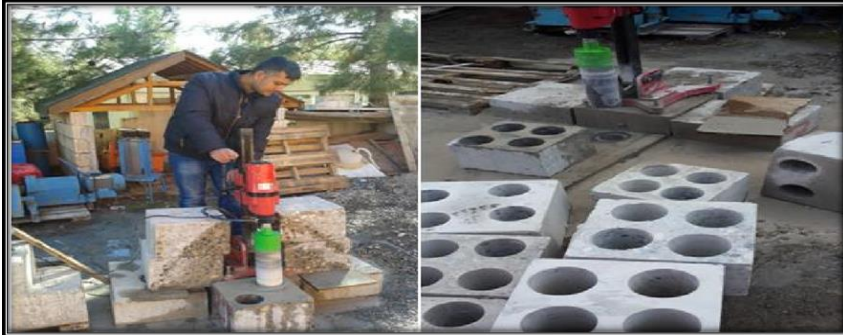
Samples were taken in line with concrete casting with coring machine. A total of 48 (12x4) cores, 10x25 cm in size, were taken from each sample as 4 cores (Figure 4 5).

Figure 4. Coring Process

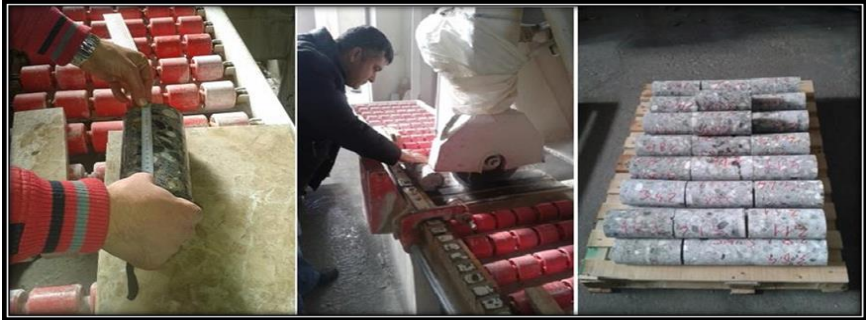
The cores with a diameter of 10 cm taken from prismatic samples were measured with a delicacy of $2\frac{1}{2}$, and the lower and upper surfaces were cut parallel to each other with the stone marble head cutting machine of the Adiyaman Marble factory (Figure 6).

Figure 6. Heading Cutting by Measuring Coring Samples in Adiyaman Marble Factory

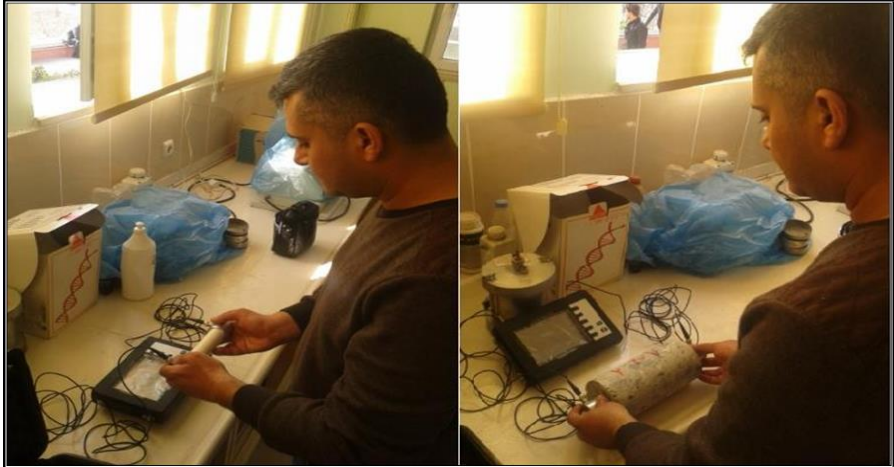
The speed at which the sound passes through the concrete is calculated in km/h by dividing the passage length between the receiver and the transmitter by the passage time.

Figure 7. Calibration of Ultrasound Device and Ultrasound Test Applied to Samples

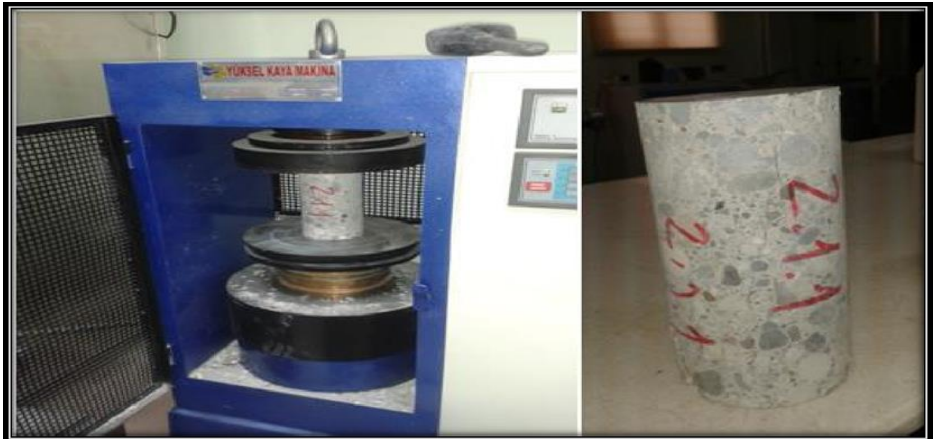
48 core samples were loaded with a 200-ton pressure press at a constant loading rate of 6 MPa/s. The highest stress values affecting the core samples were read on the computer (Figure 8). The readings are calculated from the relation $f_c = P/A$ as P (N), the area where the pressure force is applied A (mm²) and the compressive strength values as f_c (MPa).

Figure 8. Pressure Test Applied to Core Samples

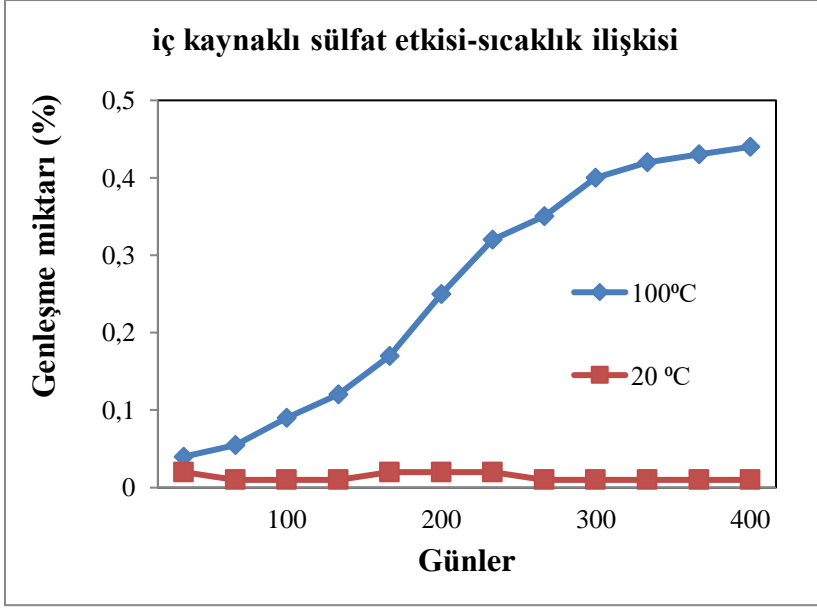
kalmaması durumunda hacim artışı oluşturmadığı tespit edilmiştir (Batic vd., 2000; Collepari, 2003). Sıcaklık etkisi ve iç sülfat etkisi ile oluşan genişleme miktarları Şekil 2’de gösterilmiştir (Yang ve Lawrence, 1999).

Şekil 2: 20 °C de ve 12 saat boyunca 100 °C’de kür gören betonların genişleme miktarları

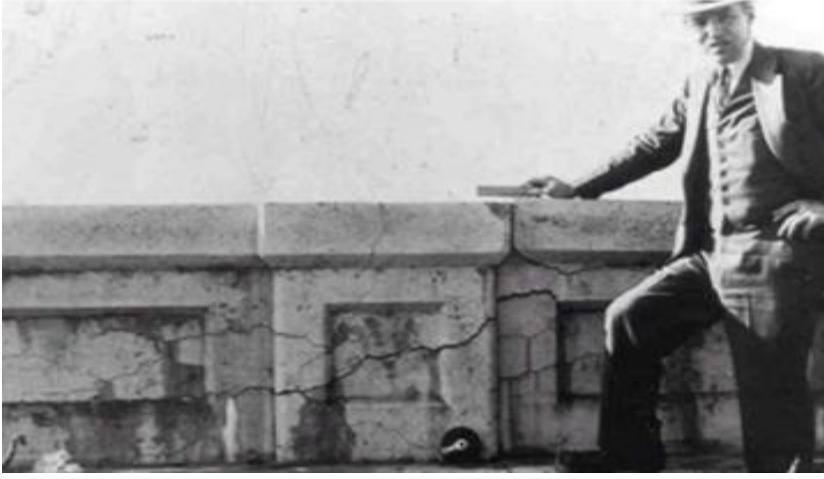
Alkali silika reaksiyonu (ASR), beton agregasındaki reaktif SiO_2 ile çimento içeriğinde alkali (Na_2O ve K_2O) bileşenlerin rutubetin etkisi ile reaksiyona girmesi sonucu oluşan bir tür bozulma şeklidir (Andiç, 2007). Betonda ASR etkisinde ilk bozulmalar, bir çok betonarme yapının derin çatlakların ve beton yüzeyinde tehlikeli beyaz birikintilerin olması üzerine 1940'lı yıllarda Amerika Birleşik Devletleri'nde üzerine Stanton tarafından tespit edilmiştir (Şekil 1) (Ferraris, 1995).

Şekil 1: Stanton ile ASR'ye maruz beton çatlakları (1940).

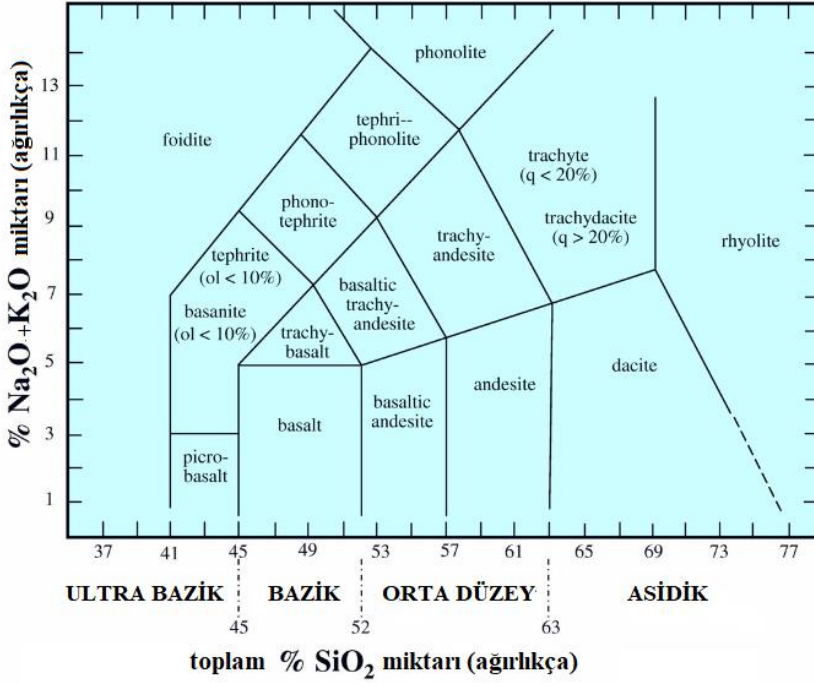
parçacıkları ve dokuları, betonun dayanıklılığında önemli bir role sahiptir. Yapılan çalışmalarda ASR'ye en reaktif kayaç andezit olduğu, dasit ve riyolitin kayaçların ASR şiddetinin daha az olduğu tespit edilmiştir (Katayamaya, 2002). Kayaçların petrografik sınıflandırılması Şekil 4' te verilmiştir (Le Maitre, 1989).

Şekil 4: Kayaçların sınıflandırılması
