CONSERVATION OF ARCHITECTURAL HERITAGE

SOUL OF HISTORY

Conservation of Architectural Heritage: Soul of History

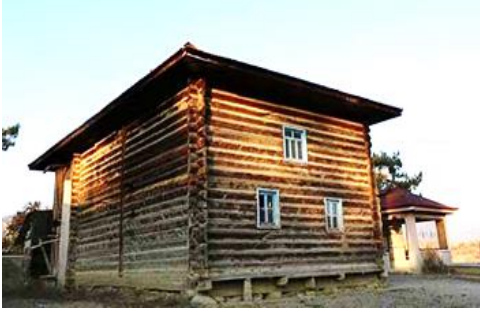
The ends of the beams placed on the foundation wall or stones are connected with a ‘*boğaz açma*’ system without using nails. After the floor beams are completed, in the construction of the walls, single pieces of wood (roughly smoothed logs or timber), usually the size of a mosque, are stacked on top of each other and connected through notches called *boğaz* (throats) opened at the corners. While the wall elements made of logs are joined with "*kara boğaz*", the elements made of processed logs or timber are joined with "*kurt boğaz*" joint. The wall elements made of timber are fixed with the help of wooden dowel pins (Figure 7).

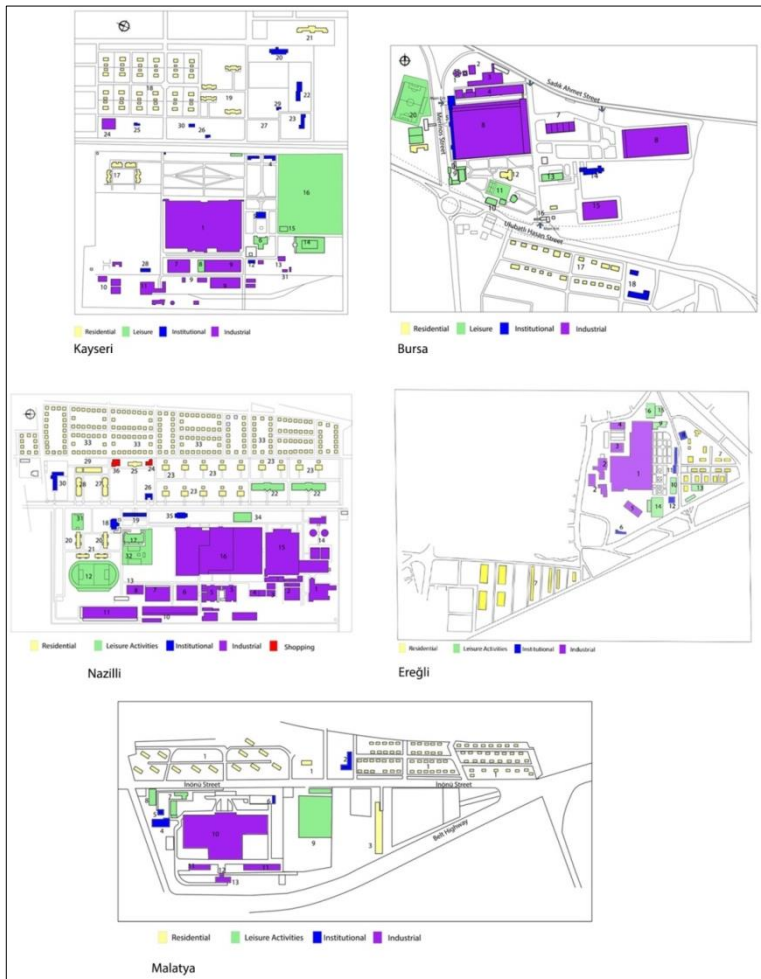
The industrial sites of Sümerbank, characterized by their intriguing and continuous history, exhibited a distinctive spatial organization (Figure 2).

Figure 2. Site plan of Sümerbank Industrial Campuses in Kayseri, Bursa, Nazilli, Ereğli and Malatya.

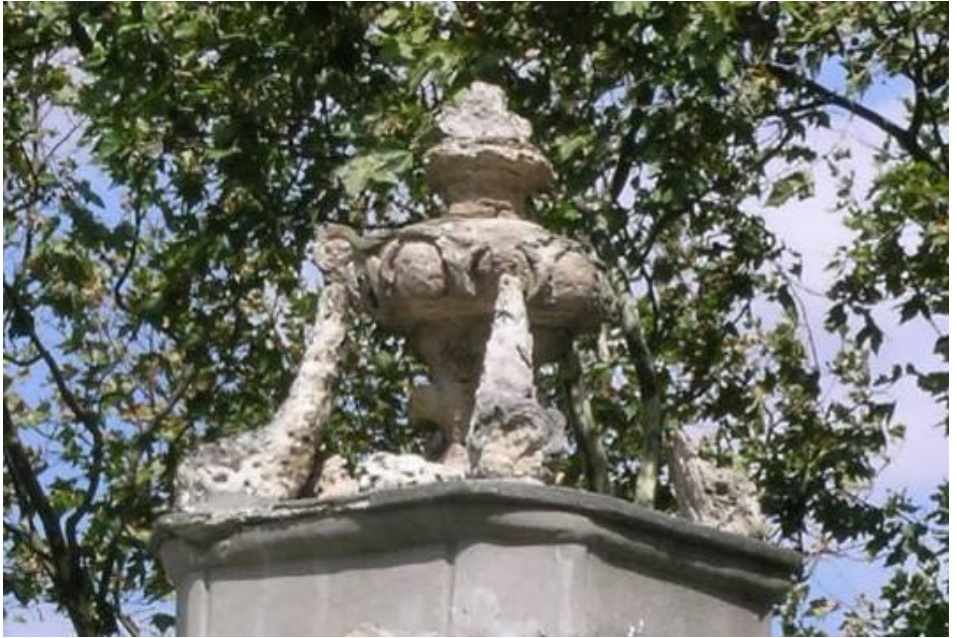
Figure 10. Cone, View of the Gate from the Palace Direction (2009)
(Author Archive, Bimtaş, 2009)

Double wreaths were used in the transition to the top, these wreaths were connected by a motif of inverted acanthus leaves in the centre, we see these wreaths hanging from volutes in the corners. The gate towers were crowned with a vase shape surrounded by an egg motif with garlands. These arrangements can be seen on all four sides of both towers (Figure 10).

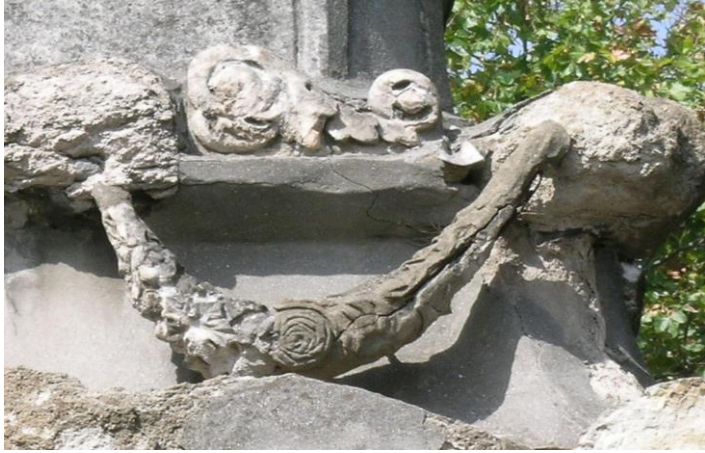
Figure 11. Detail of the Decoration on the Corner Bevels of the West Tower of the Mecidiye Gate. (Author Archive, Bimtaş, 2009)

In 2009, when the survey of the structure was carried out, it was determined that there were material and surface losses, especially in the tower cone sections that were exposed to climatic conditions and could not be intervened due to the difficulty of completing the application.

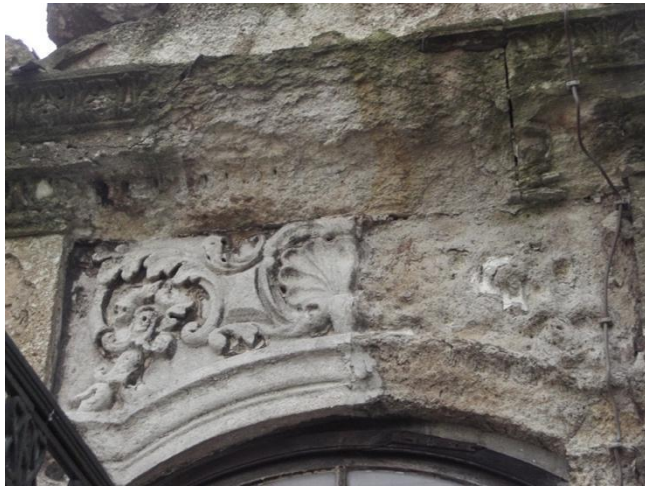
Figure 12. Detail of the Decoration on the Corner Bevels of the West Tower of the Mecidiye Gate. (Author Archive, Bimtaş, 2009)

The decorations on the facades of both towers have been largely destroyed. Since the Mecidiye Towers were built with Kufeki, a porous type of stone, they underwent some repairs using cement during the 1968 repairs, which caused further damage (Figure11-12).

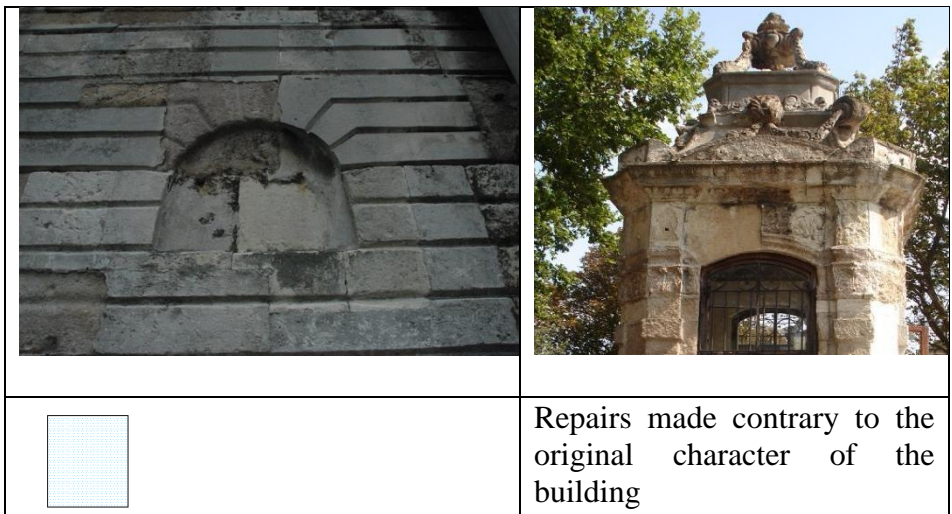
Figure 25. Mecidiye Gate Deterioration analysis (Author Archive, Bimtaş, 2009)

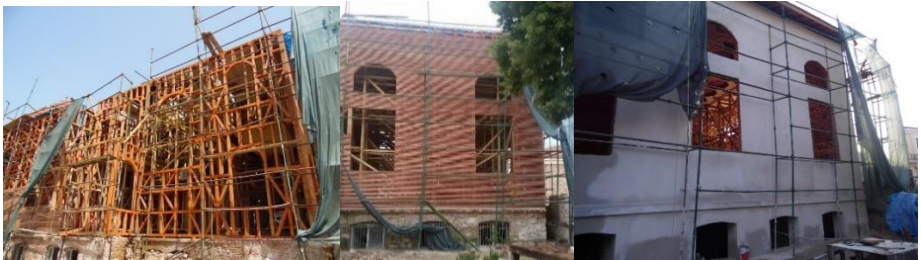
Figure 1. The restoration works included the renewal of the wooden frame system, lath strips, and plaster applications (Osmanoğlu, 2015).

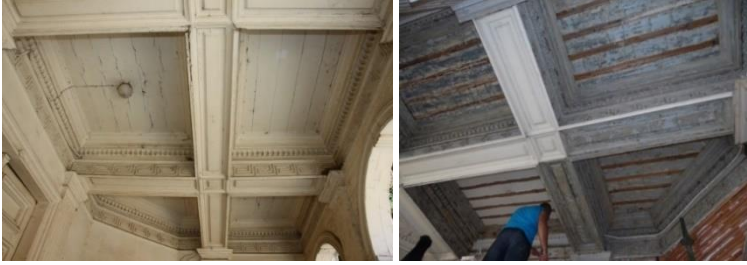
Figure 5. The condition of the building's balcony ceilings before restoration and the scraping applications (Osmanoğlu, 2015)

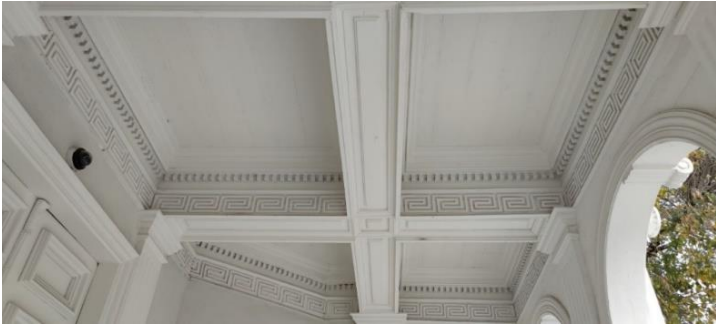
Figure 6. The condition of the balcony ceilings after restoration (Mukoviç, 2024)

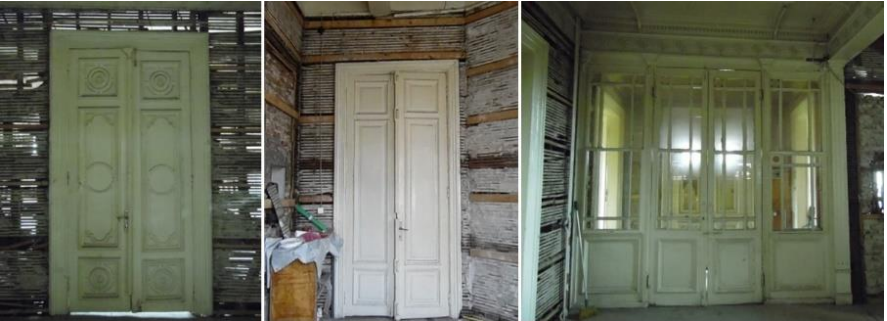
Figure 7. Doors Before Restoration (Osmanoğlu, 2015)

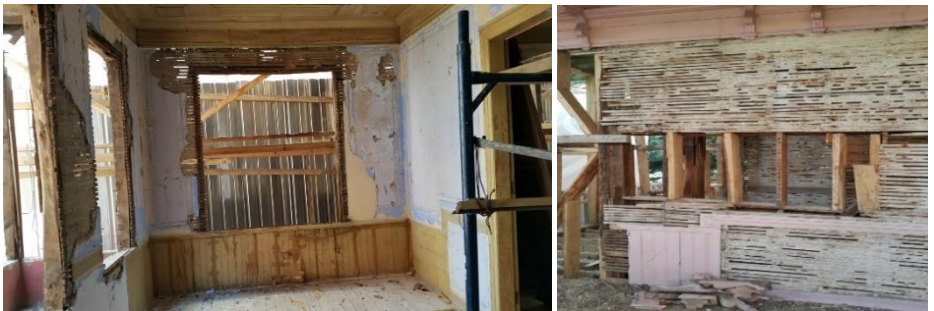
Figure 17. Interior Deteriorations (Osmanoğlu, 2017-2019)

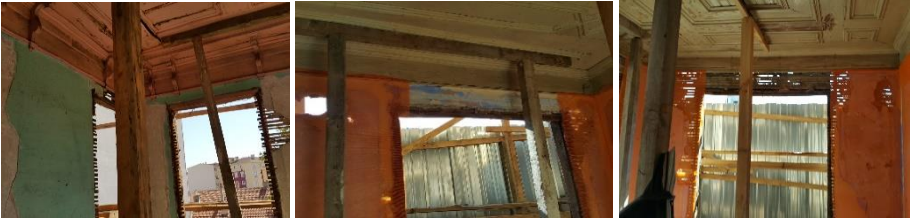
Figure 18. Suspension of the Ceilings (Osmanoğlu, 2017-2019)

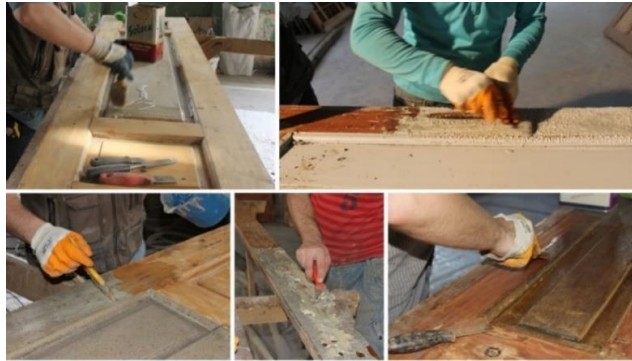
Figure 34. Mechanical and chemical cleaning applications (Osmanoğlu, 2012-2017)

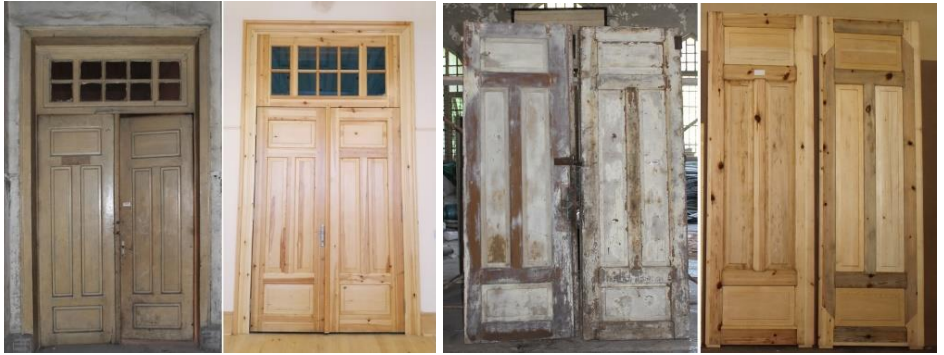
Figure 1041. The condition of the ground floor and first-floor doors before and after the application (Osmanoğlu, 2012-2017)

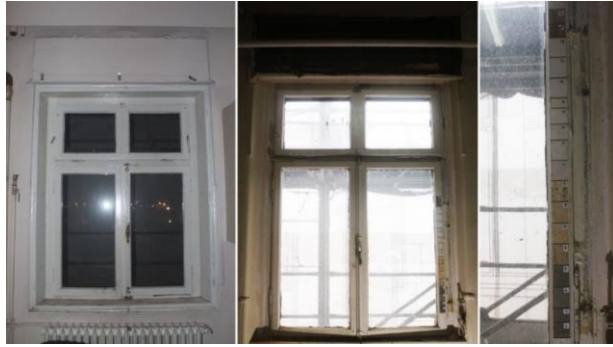
Figure 22. The view of the window before conservation and periodic paint stripping 2016-2024 (Osmanoğlu)

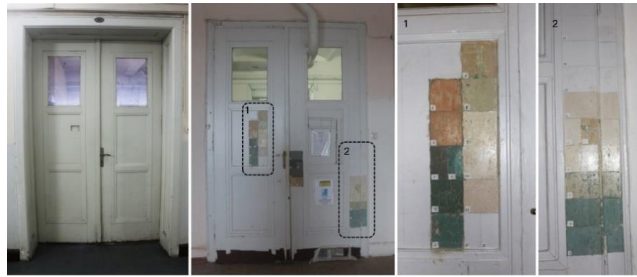
Figure 23. An example of a wooden door, showcasing its current condition and detailed stratigraphic paint layers (Osmanoğlu, 2016-2024).

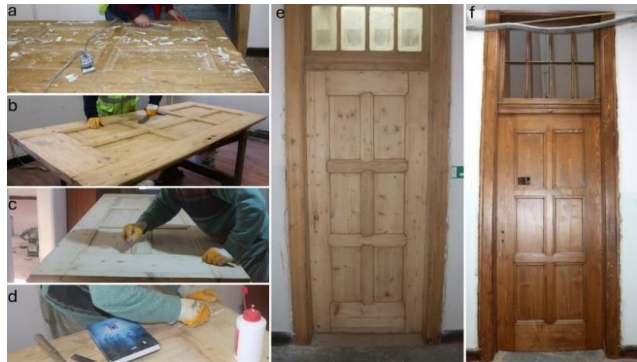
Figure 44. a) Cleaning application on the wooden door example using heat guns, b) cleaning with sandpaper, c, d) filling of gaps, e) the condition of the door after cleaning, and f) application of protective primer and varnish to the door (Osmanoğlu, 2016-2024).

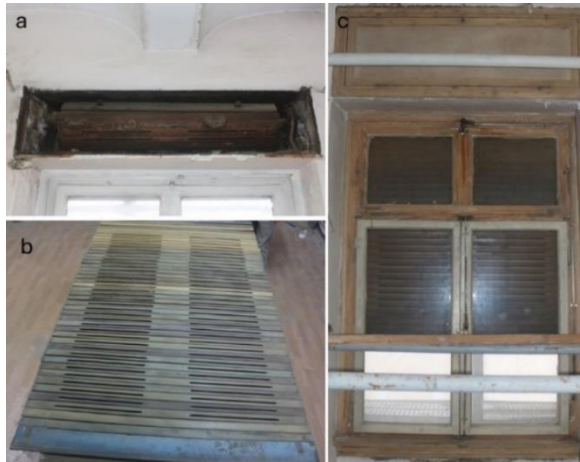
Figure 46. a) Interior of the shutter box, b) Example of the shutter during the repair process, c) Repaired shutter example installed on the window (Osmanoğlu, 2016-2024)

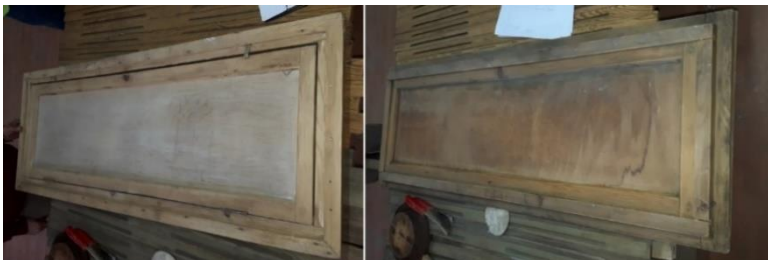
Figure 7. The front and back surfaces of the shutter box after cleaning techniques (Osmanoğlu, 2016-2024)

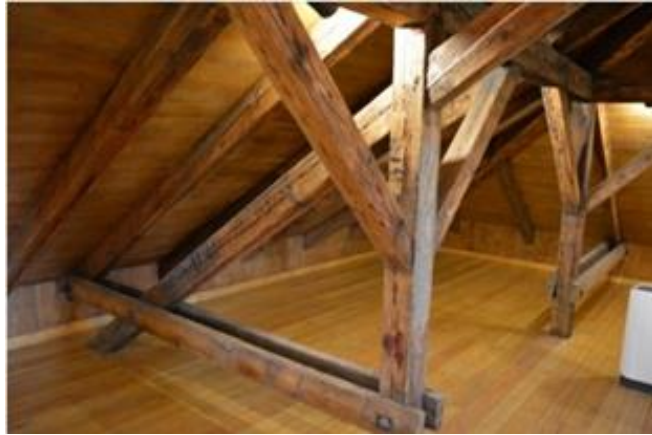
Figure 14. Original roof elements in the attic of the former German Embassy Building (Adalı, 2019)
